DEPARTMENT OF TRANSPORTATION**DIVISION OF ENGINEERING SERVICES**

Quality Assurance and Source Inspection

Contract #: 04-0120F4Cty: SF/ALA Rte: 80 PM: 13.2/13.9File #: 69.15**SOURCE INSPECTION REPORT****Resident Engineer:**Pursell, Gary**Address:** 333 Burma Road**City:** Oakland, CA 94607**Report No:** SIR-002513**Date Inspected:** 17-Jul-2010**Project Name:** SAS Superstructure**OSM Arrival Time:** 700**Prime Contractor:** American Bridge/Fluor Enterprises, a JV**OSM Departure Time:** 1900**Contractor:** Zhenhua Port Machinery Company, Ltd (ZPMC), Changxing Island **Location:** Shanghai, China**Quality Control Contact:** Mr. Don Walton**Quality Control Present:** Yes No**Material transfer:** Yes No N/A**Sampled Items:** Yes No N/A**Stock Transfer:** Yes No N/A**OK to Cut:** Yes No N/A**Rebar Test Witness:** Yes No N/A**Delayed/Cancelled:** Yes No N/A**Other:** Coating Inspection**Bridge No:** 34-0006**Component:** See Below**Bid Item:** 77, 78, 79**Lot No:** B #204**Summary of Items Observed:**

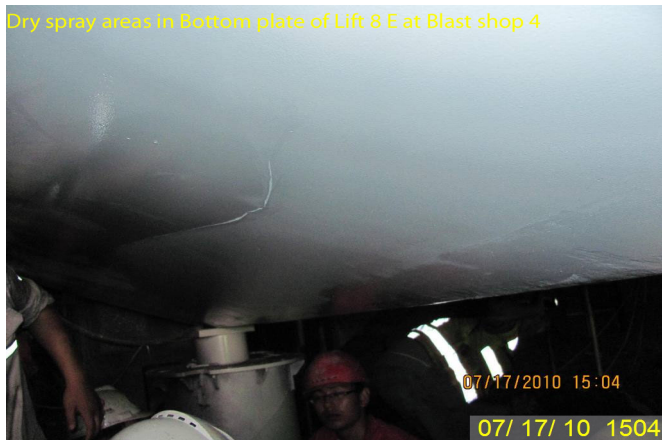
3. An inspection was requested on the OBG Segment, Entire External surface of Lift 8 E for DFT check and final acceptance, vide request no. 3709 at Blast shop no. 4. Caltrans Engineer Mr. Aaron Prichlik have been informed for the same. This was found Rejected by ABF Inspector Mr. Sun for bottom plate areas not finished properly. This was again offered for inspection vide notification no. 3712. Mr Aaron Prichlik from Caltrans came to the spot for final acceptance inspection and He rejected the same for wrnkling, Orange peel and high DFT in touch up area edges. International protective coatings technical service representative was not found present during the course of this inspection process. (Photo attached)

Dry spray areas in Bottom plate of Lift 8 E at Blast shop 4

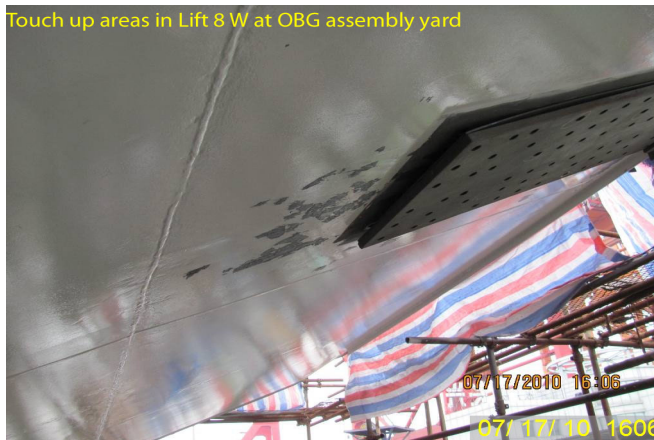
final acceptance, vide request no. 3710 at OBG assembly yard. Caltrans Engineer Mr. Aaron Prichlik have been informed for the same. This was found Rejected by ABF Inspector Mr. Sun for bottom plate areas not sealed by Interfine 979 and Damaged areas at the suspender Bracket areas not attended. This was again offered for inspection vide notification no. 3713. Mr Aaron Prichlik from Caltrans came to the spot for final acceptance inspection and He rejected the same for wrinkling and Balance finish paint application in near suspender Bracket areas. International protective coatings technical service representative was not found present during the course of this inspection process. (Photo attached)

Touch up areas in Lift 8 W at OBG assembly yard
